REFURBISHMENT OF THE  
KURDISTAN REGIONAL GOVERNMENT  
MINISTRY OF INTERIOR COMPLEX  
UNDER THE COMMANDER'S EMERGENCY RESPONSE PROGRAM  
ERBIL, IRAQ

**SIGIR PA-08-119**  
**APRIL 17, 2008**

SUBJECT: Report on Project Assessment of the Refurbishment of the Kurdistan  
Regional Government's Ministry of Interior Complex, Erbil, Iraq  
(Report Number SIGIR PA-08-119)

## **Refurbishment of the Kurdistan Regional Government Ministry of Interior Complex Erbil, Iraq**

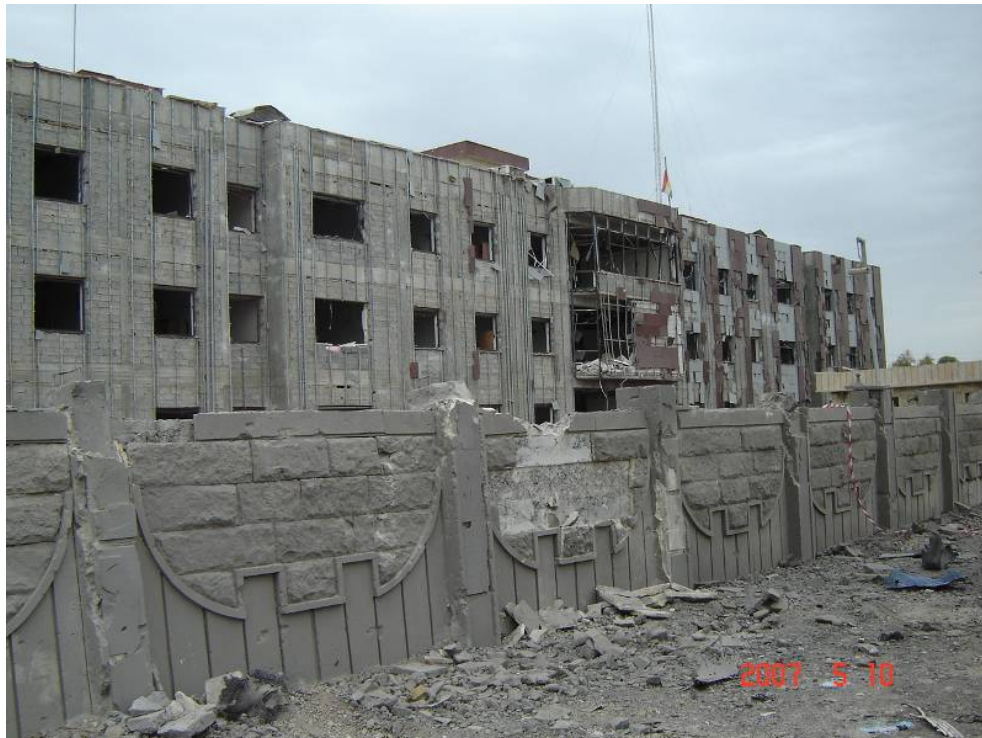
**Site Photo 1. Damage to the north side of the services building & perimeter wall.  
(Photo courtesy of USACE)**

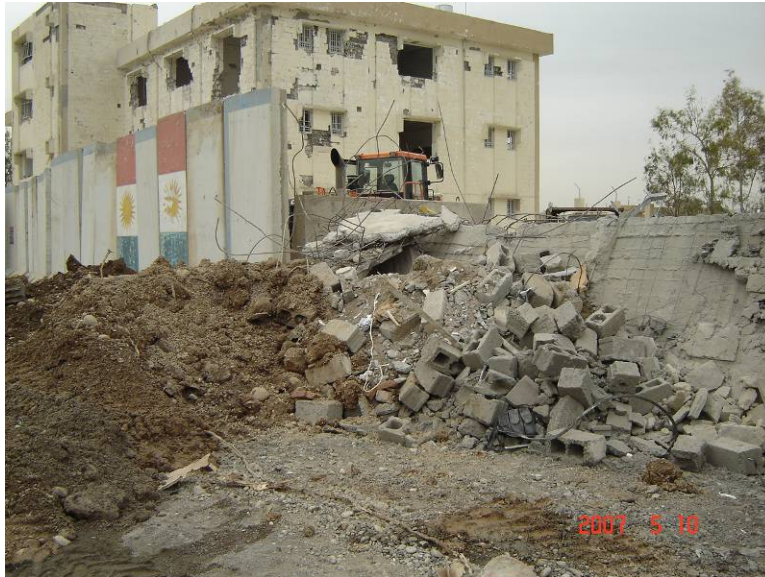
**Site Photo 2. Security building damage (Photo courtesy of USACE)**

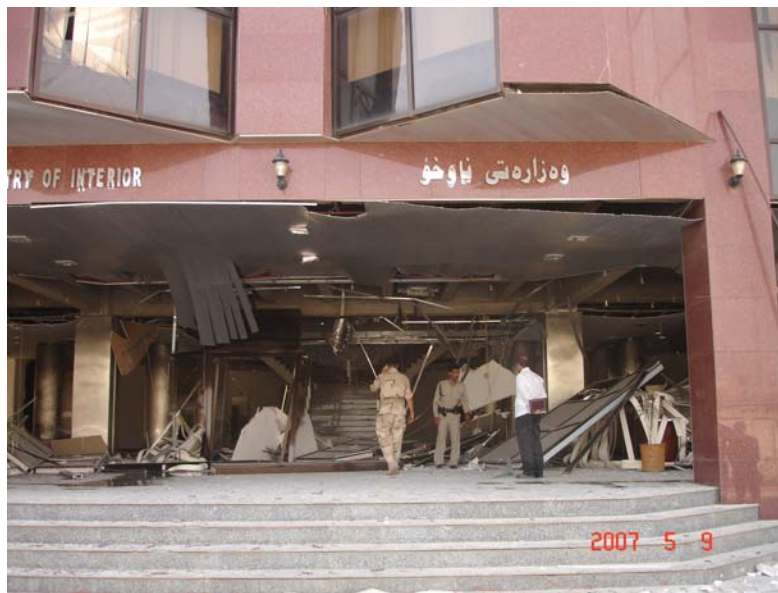
**Site Photo 3: Entryway to MOI building (Photo courtesy of KRG)**

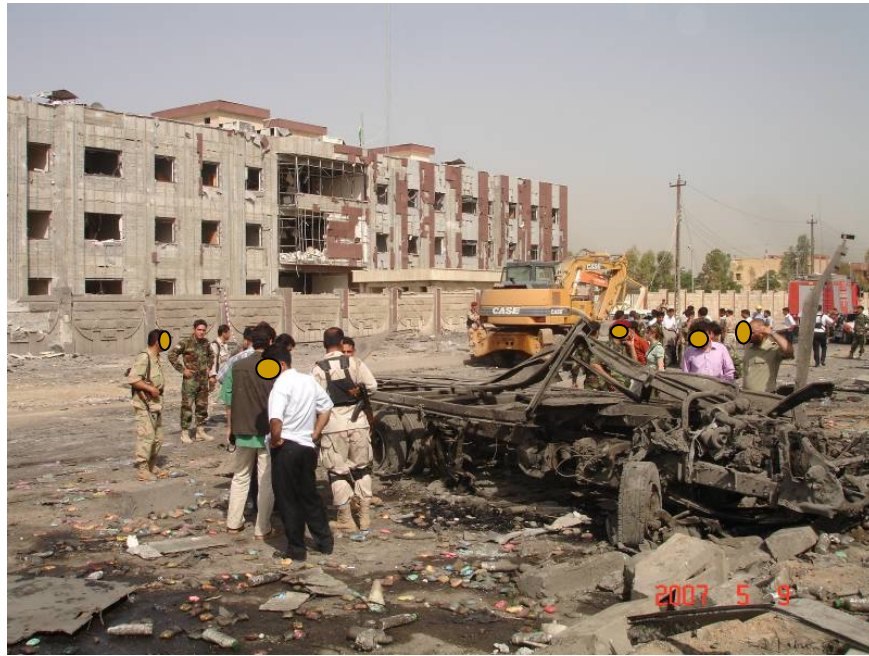
The northern side of the services building was extensively damaged from the blast. All of the windows were blown out and most of the granite siding shattered and fell to the ground posing significant danger to anyone standing near the building. The granite siding was replaced with a stucco finish to eliminate the threat of it falling during any future attack. Site Photos 4 and 5 show the destroyed and repaired building.

**Site Photo 4: Damage to the services building and perimeter wall  
(Photo courtesy of KRG)**

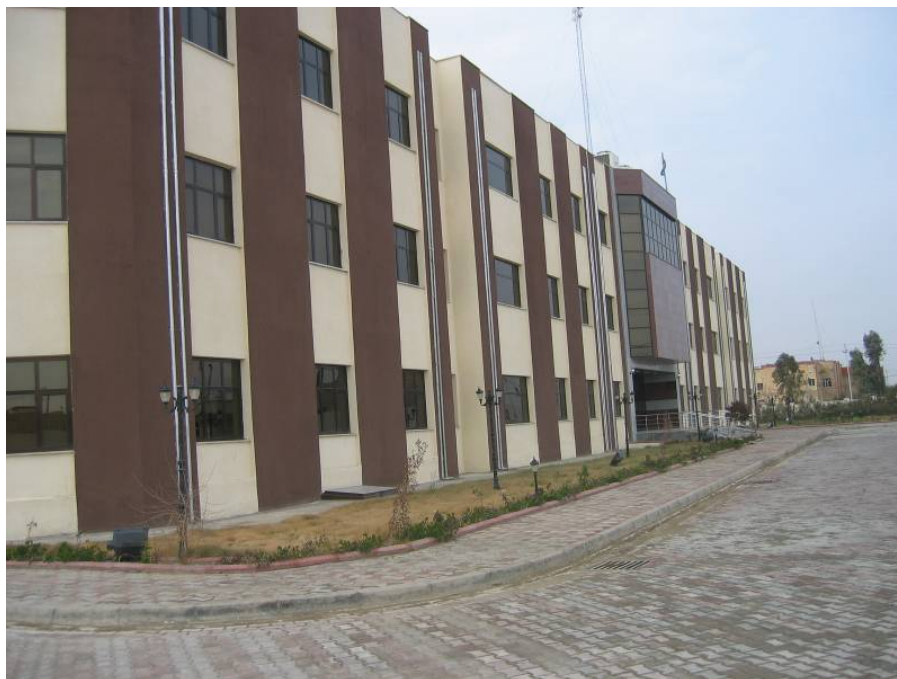
**Site Photo 5: Refurbished services building**

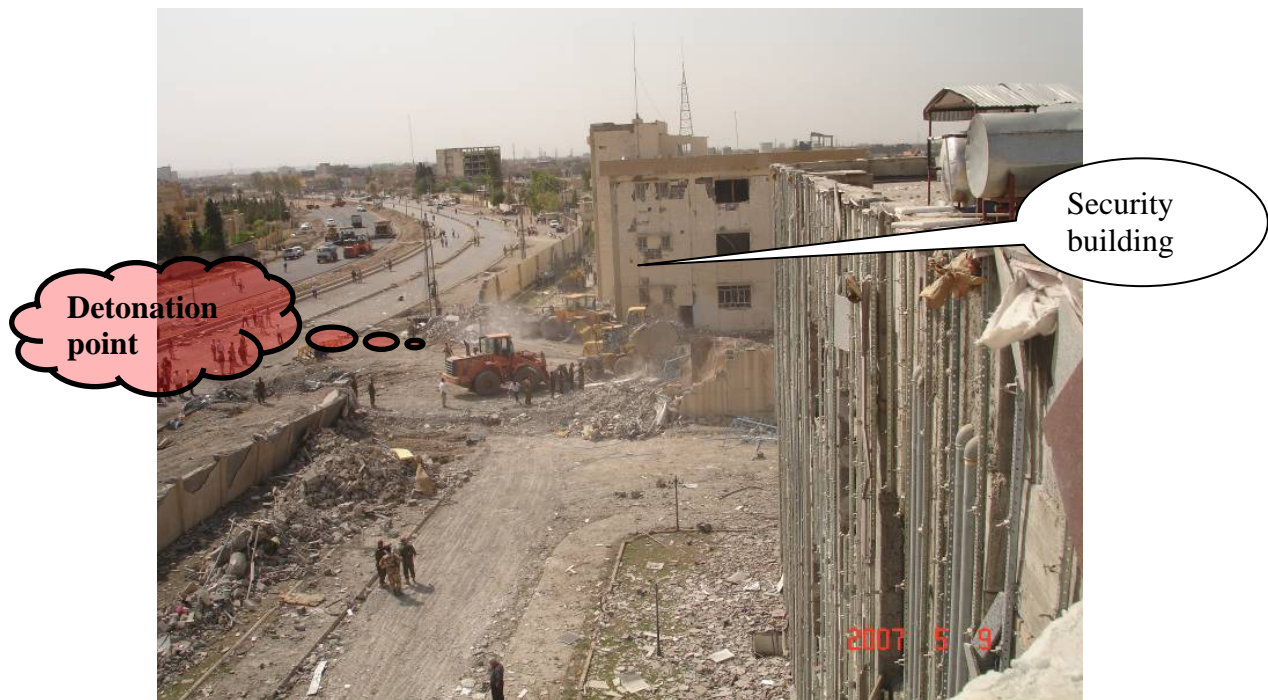
The VBIED detonated at the northeast entry gate, destroying the guard shack and severely damaging the perimeter wall. The guard shack was rebuilt, the perimeter wall repaired, and T-walls were erected along the “60-Meter” road that passes the complex. Site Photos 6 and 7, taken from the roof of the services building show the destruction and completed repairs.

**Site Photo 6: Damage to the perimeter wall, services building and security building.**  
**(Photo courtesy of KRG)**

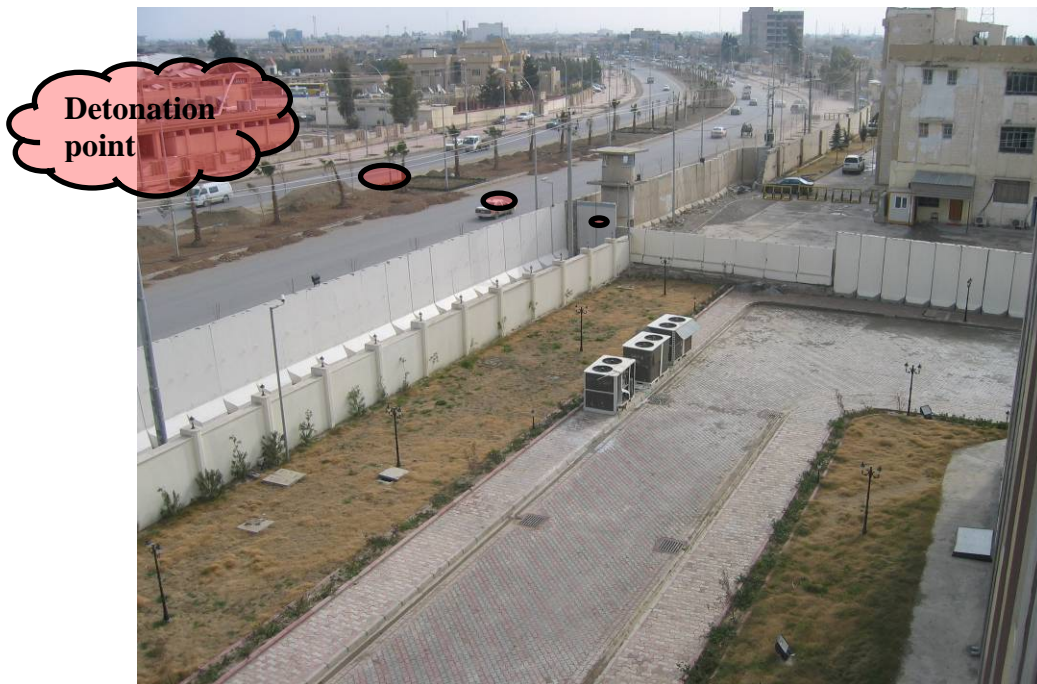
**Site Photo 7: Repaired wall, installed T-walls and reconstructed guard shack.**  
**Photo taken from the roof of the services building.**

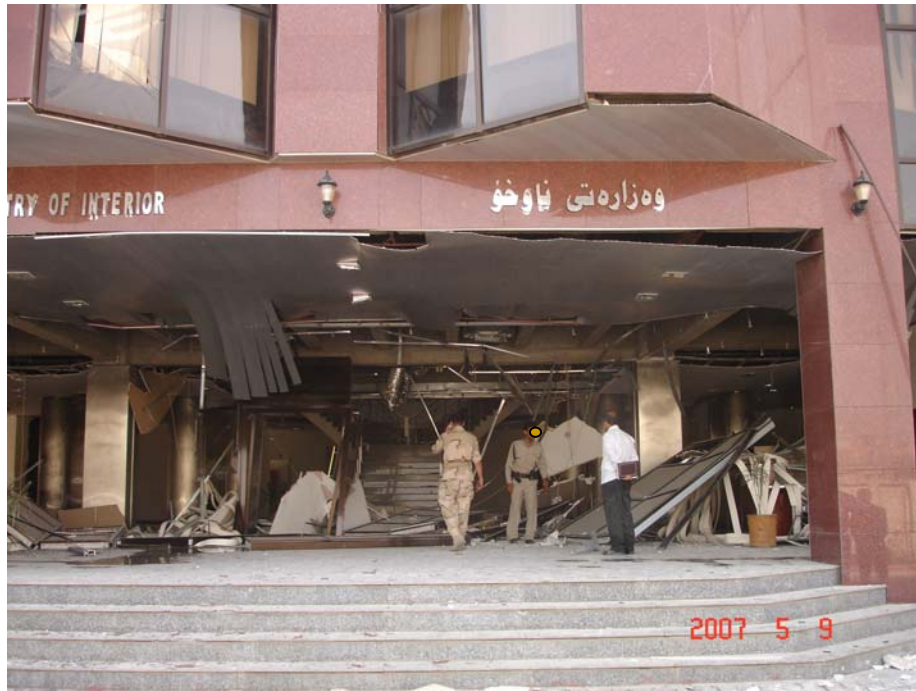
The MOI main entrance is located at the southwest part of the complex. The blast carried through the building interior and blew out the entrance doors, windows, and ceiling. The

granite siding was not damaged and was retained in the new construction. Site Photos 8 and 9 show the destruction and completed repairs.

**Site Photo 8: The MOI entrance was located at the opposite side of the complex from the blast which carried through the building interior. (Photo courtesy of KRG)**

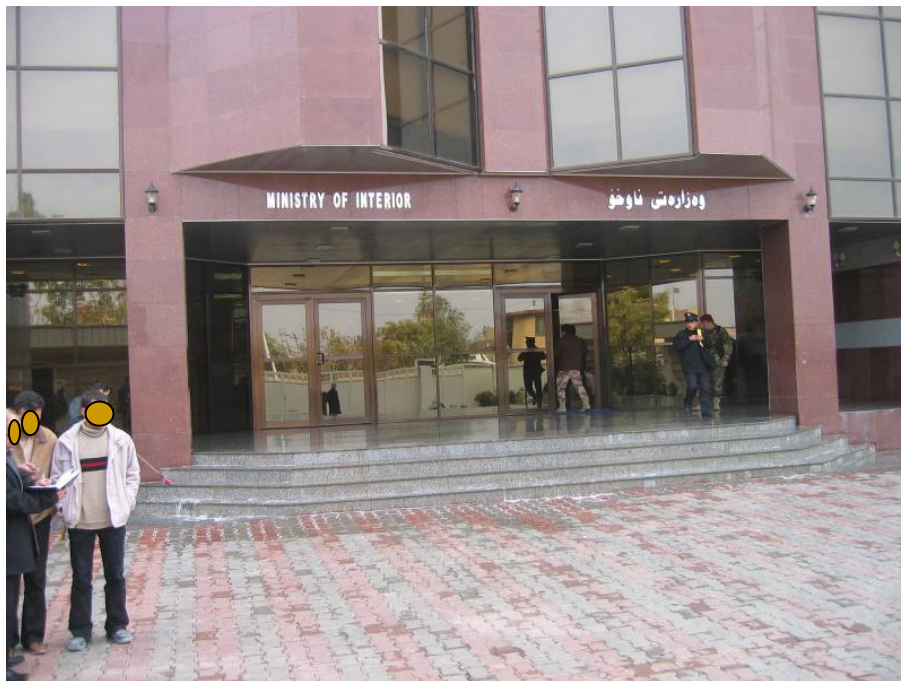
**Site Photo 9: Repaired MOI entrance**

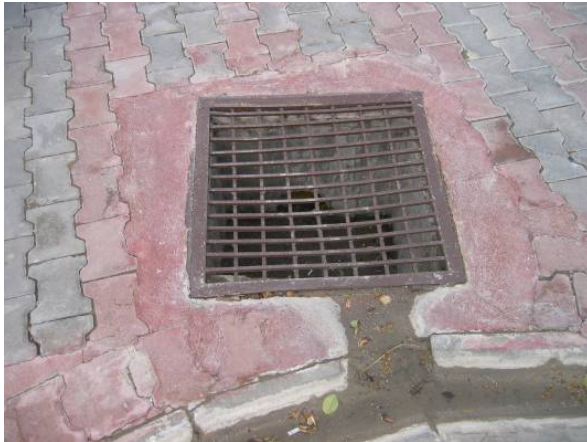
photographed the landscaping and noticed the general slope of the grounds. It had recently rained and there was no evidence of water pooling. There was an efficient network of manholes, culverts and piping to collect and convey runoff water offsite. At the garage entrance, a culvert captured water that drained down the driveway and a sump pump moved the water vertically up the driveway wall to the upper road and into the drainage ditch. Site Photos 10 and 11 show two water drainage components.

**Site Photo 10. Roadside drainage ditch emptying into a manhole**

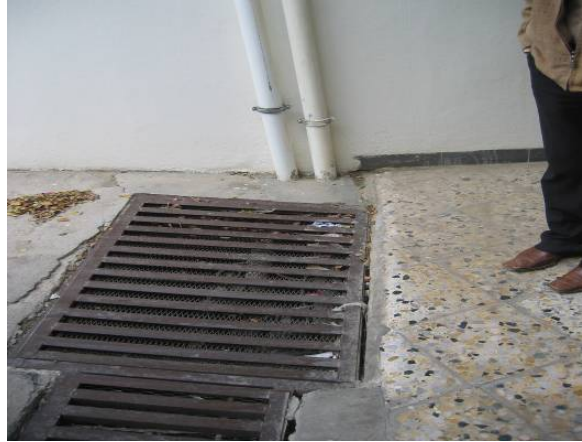
**Site Photo 11. Garage culvert with a sump pump that moves water vertically to the roadway approximately three meters above the driveway**

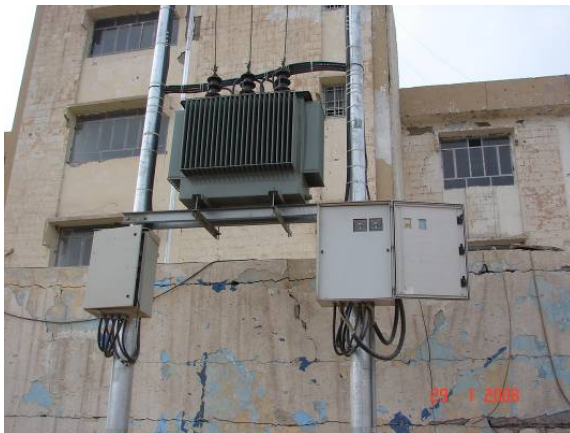
The contract required installation of one 250 kilovolt amp (kVA) and one 400-kVA transformer. The work included providing poles for 11-kV high-voltage lines with all accessories to be energized. Site Photos 12 and 13 show both transformers were installed and connected to power lines adjacent to the complex.

**Site Photo 12. 400-kVA Transformer**  
(Photo courtesy of GRN)

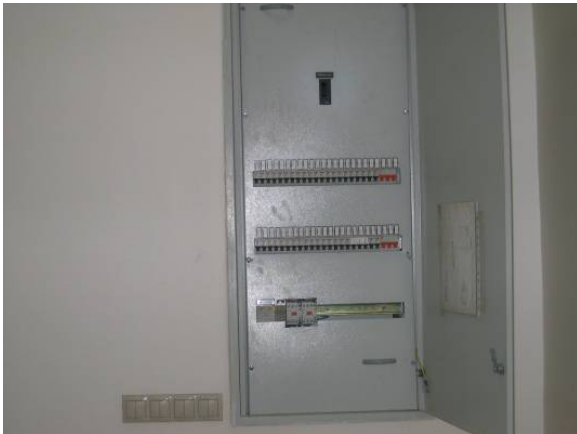
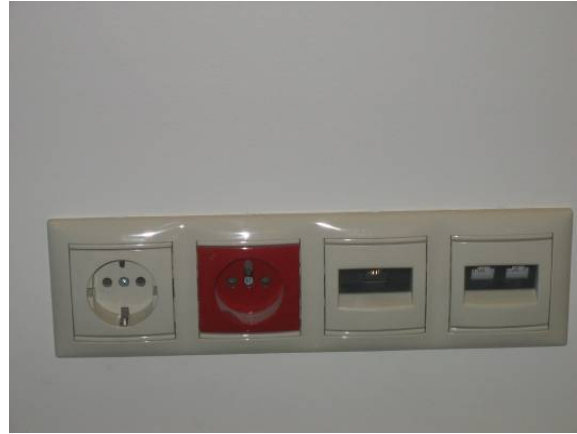
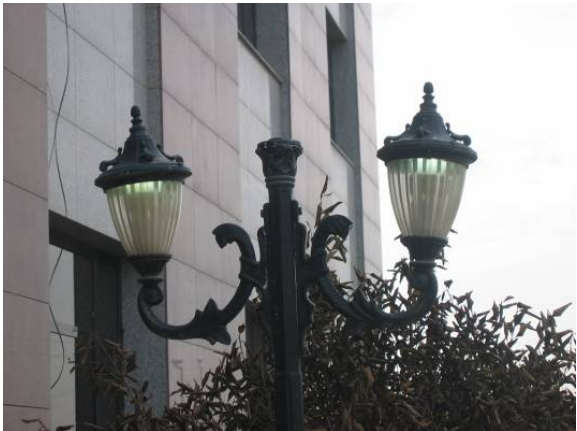
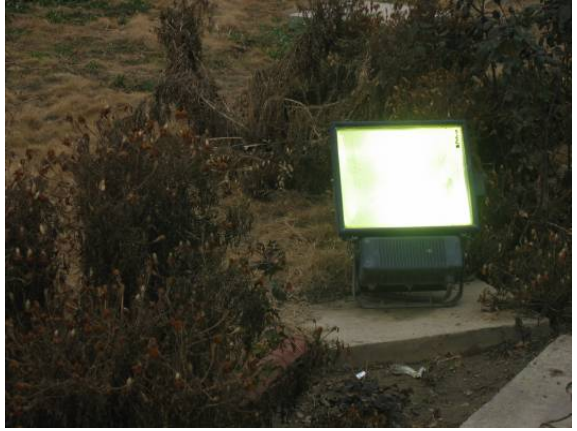
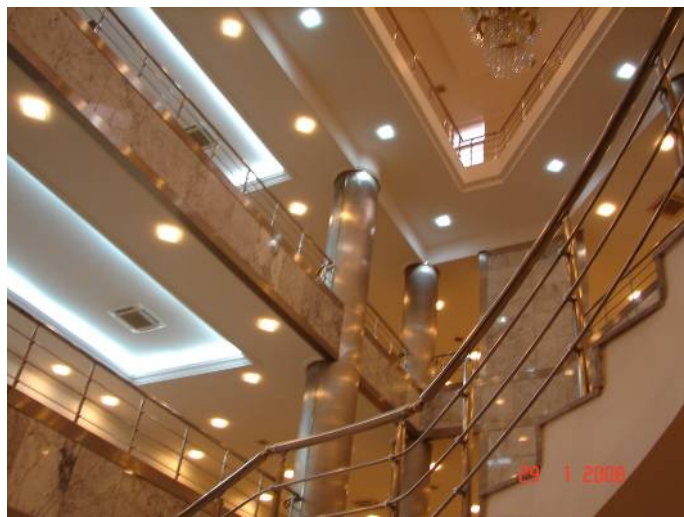
The contractor assessed circuit breakers, electrical fixtures, and lights for damage and made necessary replacements. Our observation showed that circuit breaker panels, electrical outlets, and light fixtures were operating, in good repair and constructed with adequate materials. Site Photos 14 through 18 show the condition of the electrical components.

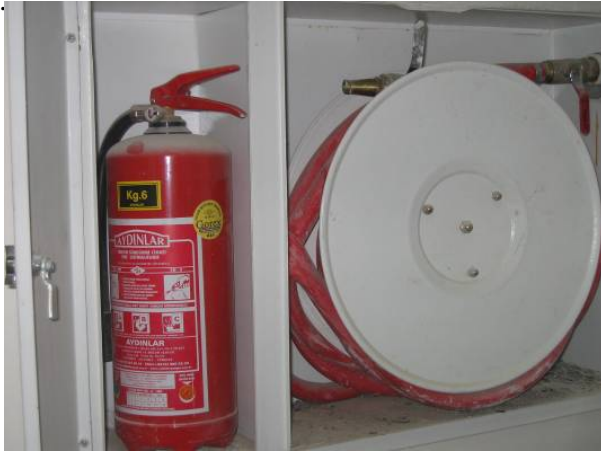
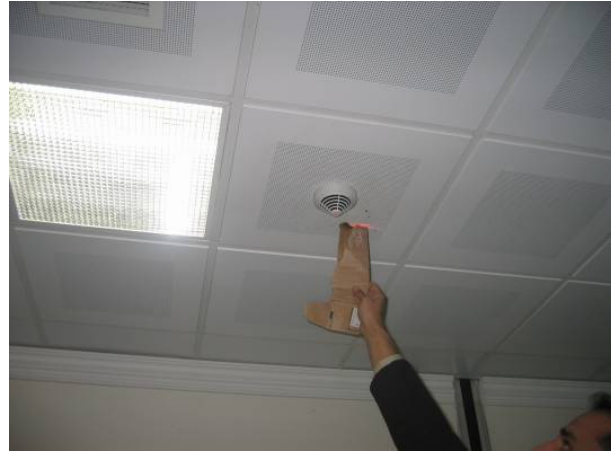
We observed fire alarm sensors and fire fighting equipment and found them to be in good condition. We also tested the alarm system in the services building by holding a burning piece of cardboard to a sensor. The first test did not work and they discovered the system

had been turned off by an employee who was performing maintenance in the control room. When the system was re-energized, the test with the burning cardboard passed. The GRN RE noted that the system should not be that easy to deactivate and added a punch list item securing the system from being deactivated unless authorized. Site Photos 19 and 20 show sample fire extinguishers and the system test.

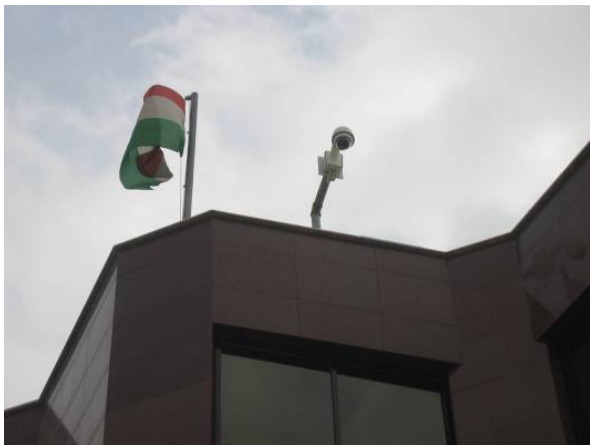
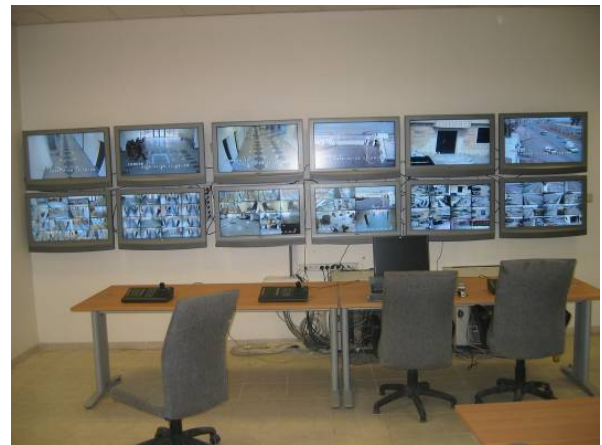
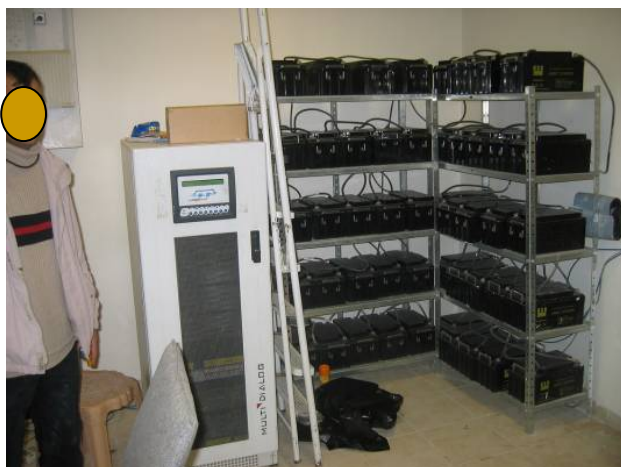
We observed and photographed a number of security cameras around the facility perimeter and visited the security control room to observe the camera monitors. Twelve newly installed Sony monitors provide good resolution and coverage of the entire complex. The system includes telephoto capability that allows close-ups adequate to read license plates on vehicles traveling along the perimeter roads. We also observed and photographed the backup system of batteries and uninterrupted power supply systems located in the room. Site Photos 21 through 23 show a security camera and control room equipment.

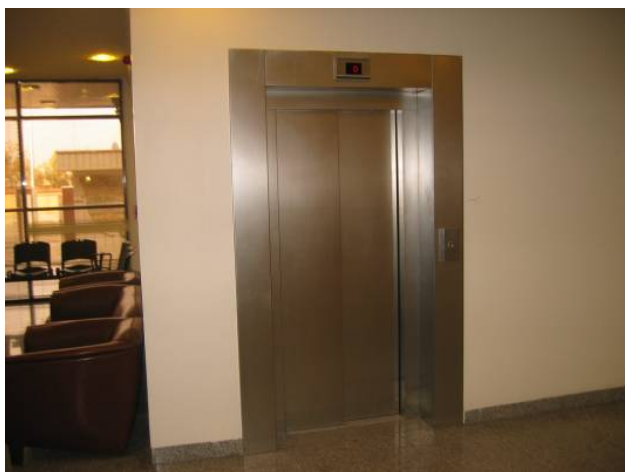
We rode one elevator in the MOI building to the third floor. The ride was smooth and the elevator started and stopped, level with the floor, without jerking. Site Photo 24 shows the elevator condition at the time of our site visit.

**Site Photo 24. Elevator in MOI building**

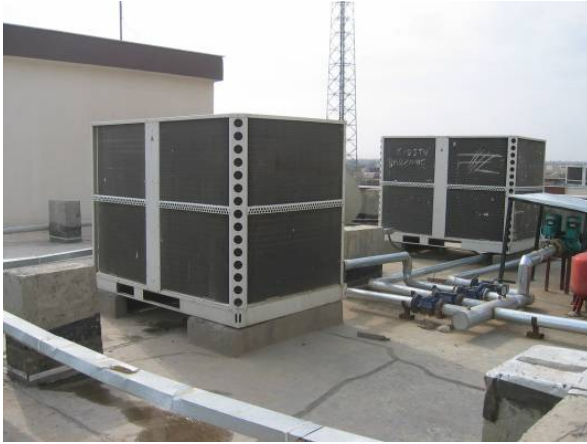
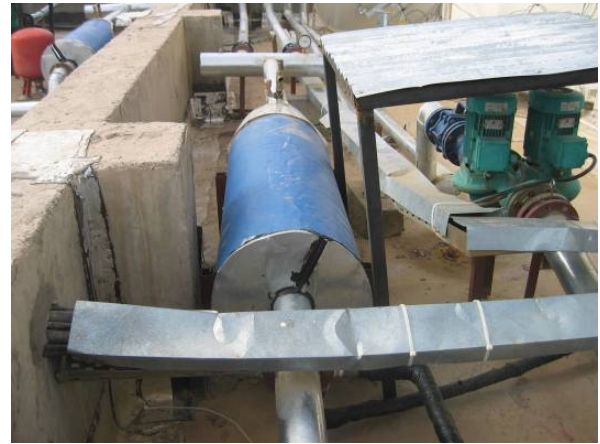
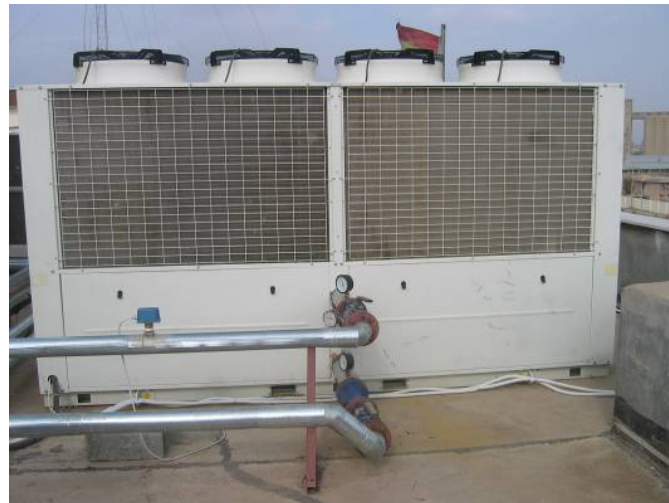
The contractor assessed the state of the heating and cooling system after the bomb-blast. Damaged chillers and fan coil units were replaced and retained for spare parts. The heating and cooling system design facilitated independent temperature controls for different zones in the buildings, which enabled systems in unoccupied offices to be turned off. We noted that the temperatures throughout the buildings were consistent and well regulated. Site Photo 25 through 27 show the rooftop heating and cooling equipment on the services building.

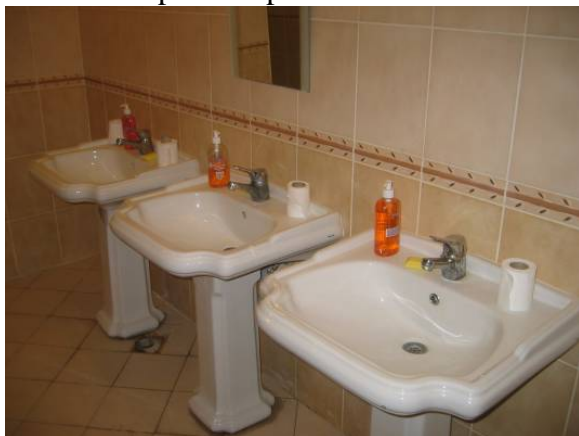
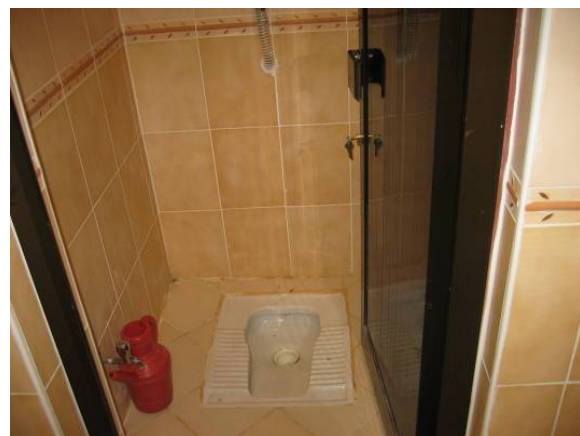
We observed and photographed the plumbing in a number of bathrooms including the basement of the ministry and services buildings. The plumbing and fixtures were of good quality and functioned properly. Site Photos 28 and 29 show the material quality and workmanship in sample bathrooms.

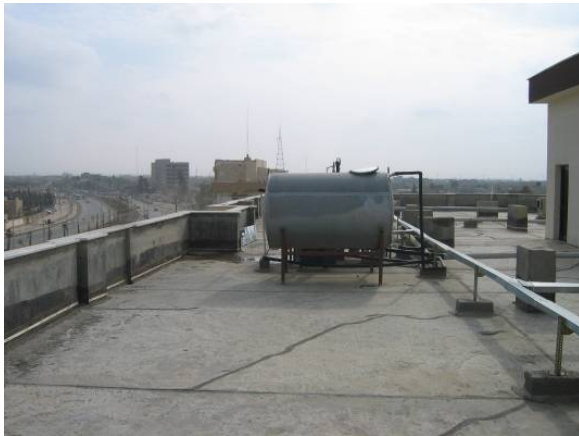
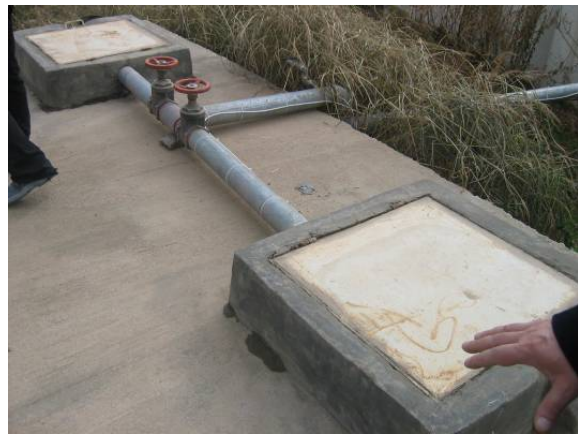
Fresh water is provided by the city waterline and from a deep-water well located at a secured property across the street from the MOI. Water comes in through the perimeter wall into two separate locked tanks where it is treated and then pumped to rooftop tanks for distribution within the facility. With the exception of the rooftop tanks, the domestic water supply had minimal damage to the outside supply system. We observed and photographed the incoming lines to the storage tanks and noted the access covers were secured with locks to prevent tampering. We found the system to be adequate and functioning. Site Photos 30 and 31 show the rooftop tank and secured treatment tanks.

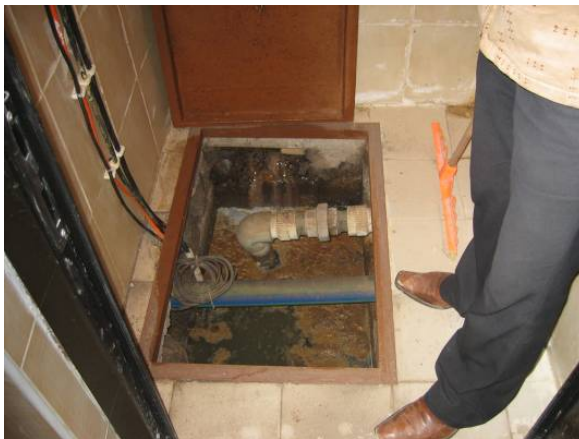
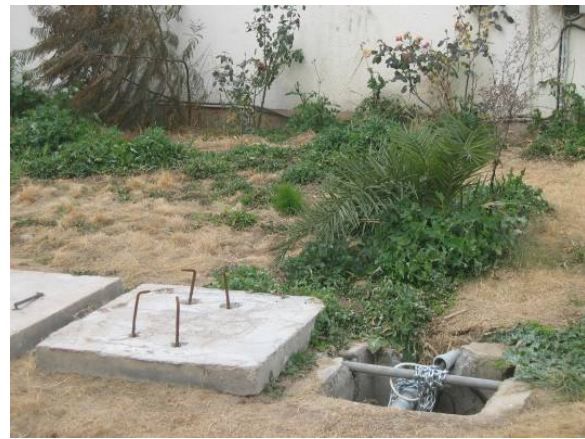
The sewage system includes a number of sump pumps that transfer wastewater through a system of pipes which drain into septic tanks located near the perimeter walls. The system was operating and there were no apparent leaks anywhere throughout the system. Site Photos 32 and 33 show the sump pump in the ministry basement and the outside septic tank covers.

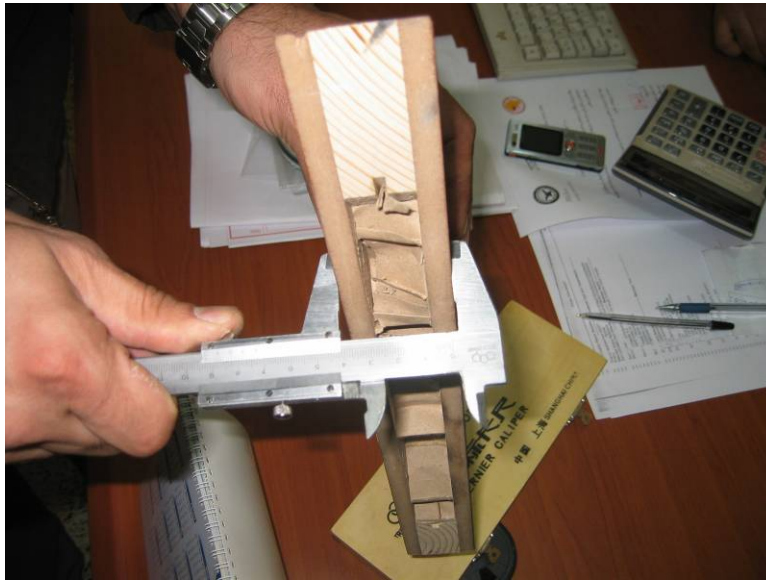
We observed and photographed a crosscut section of a new door (Site Photo 34) and tested a sample of doors which operated properly.

**Site Photo 34. Cross section of an upgraded interior wooden door**

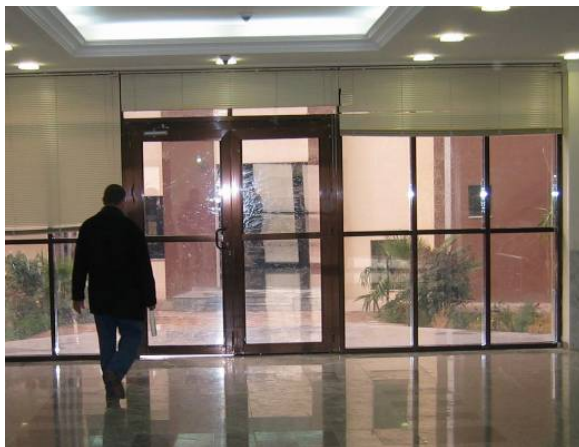
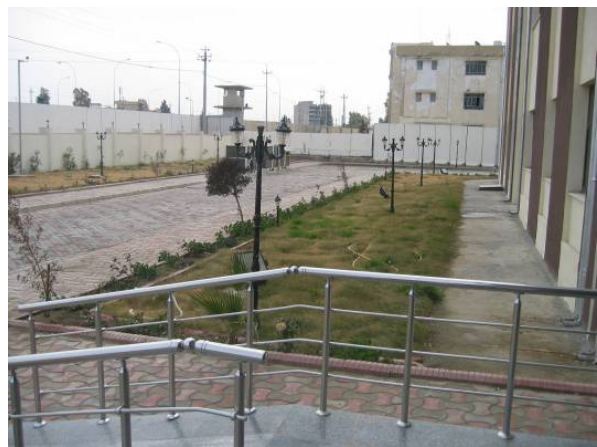
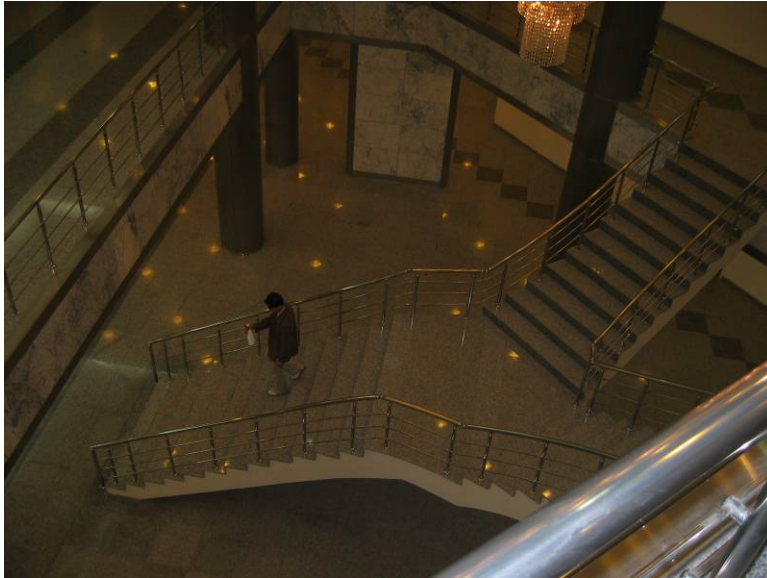
Aluminum doors were installed at the building entrances and bathrooms. The new materials were 30 percent thicker (2 centimeters (cm) vs. 1.5-cm) than those used in the previous construction. Handrails were repaired or replaced with the same quality material as before. We observed, photographed, and tested the operations of a sample of doors in the ministry and services buildings and found them to function properly. The handrails were stable and well anchored. Site Photos 35 through 37 show examples of the new aluminum doors and refurbished handrails.

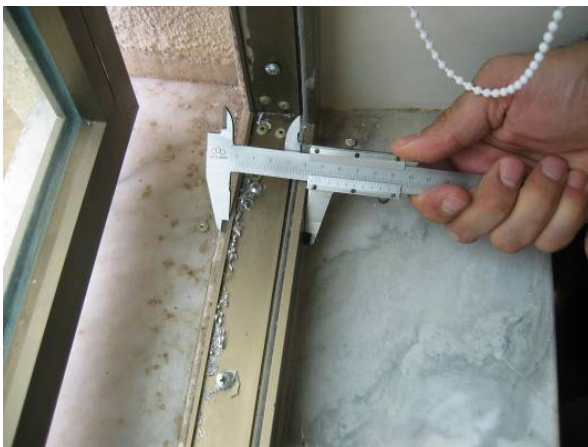
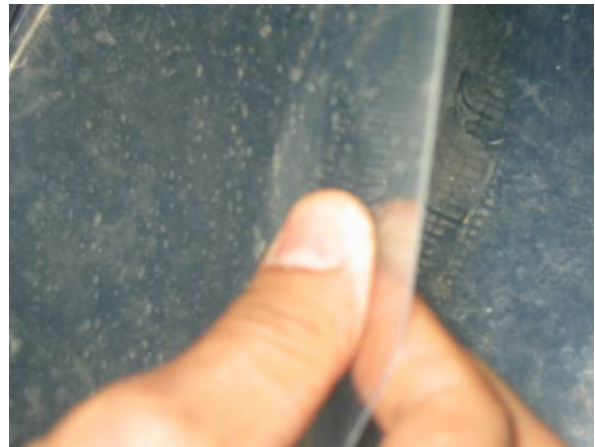
- a. The contract required installation of blast proof windows in the minister's office, reception room, and secretary's office. We observed, photographed, and measured the blast proof windows installed in the minister's reception room and adjacent secretary's and entry rooms.
- b. The windows in the remaining parts of the complex were replaced with thicker aluminum frames {(2.0-cm vs. 1.5-cm) (Site Photo 38)} and double paned glass with a vacuum sealed space between. The interior glass was coated with 21-mil (equals 0.021 inches) protective film (Site Photo 39) to prevent shattering in the event of another blast.

**Site Photo 39. Protective film was installed on interior side of windows to prevent shattering**

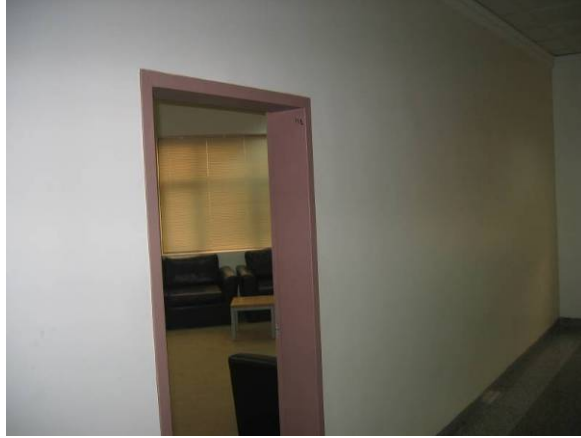
We observed and photographed the exterior and interior walls in the services, ministry, guard, and conference buildings and found them to be adequately plastered/stuccoed and painted. Site Photo 40 shows an example of a refurbished interior wall.

**Site Photo 40: Example of a finished interior wall**
